## Technical Tip

NO	Tech-Tip No.	Model	Published by	Date	Public Scope
1'st Edition	PRT-T1734	C30/C40 Series. SL-C3010ND/XAA, 3010DW/XAA, C3060ND/XAA, C3060FW/XAA, C3060FR/XAA ,SL-C4010ND/XAA, C4012ND/XAA, C4062FX/XAA	ChulWoo Oh	May.26 <sup>th</sup> . 2017	All

■ **SUBJECT :** Cosmetic Appearance unacceptable to customer

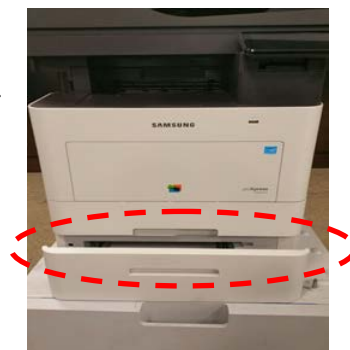
**Symptom:** Customer cannot accept the fact that the cassette protrudes out past the front of the device

**Cause:** When the Legal Cassette is installed, it protrudes out past the front of the device. This is because the paper path of the device is in the rear of the cassette, which forces the extension of the tray to the front when loading Legal

This may cause dust contamination on the Feed Rollers in the Cassette resulting in jamming; or dissatisfaction on the part of the customer because of the appearance of the device when the Legal Cassette is installed

**Solution:** We have designed a cover for use with the LEGAL Cassette, which covers the gap on the front of the cassette. This will take care of the two issues listed above.

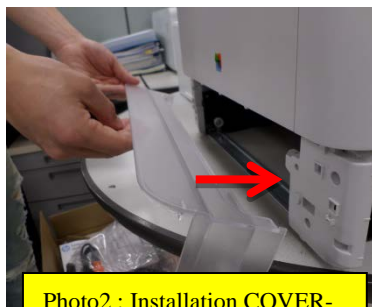
Photo2 : Installation COVER-CASSETTE

Mounted photo

For the cover installation, please see Photo2.
