2020 Buick Truck Enclave AWD V6-3.6L

FRONT BRAKE GRIND/GROAN NOISE AFTER SITTING OVERNIGHT

#21-NA-142: Front Brake Grind/Groan Noise After Sitting Overnight - (Jan 8, 2025)

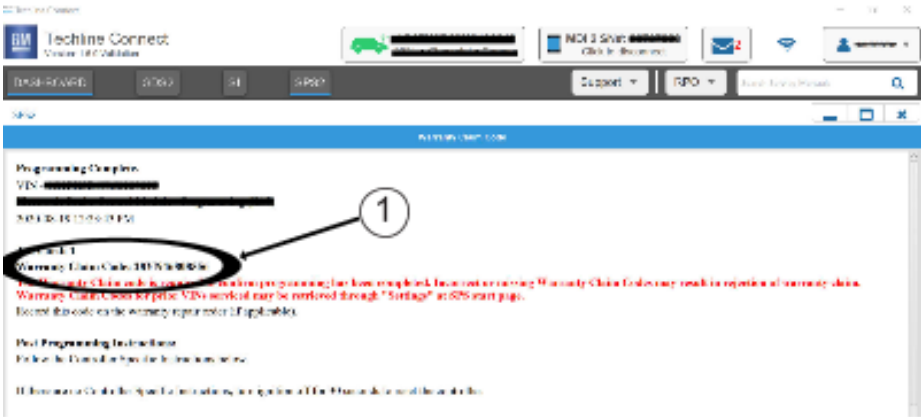
**Note:** The screenshot above is an example of module programming and may not be indicative of the specific module that is being programmed. Module selection and VIN information have been blacked out.

**Important:** To avoid warranty transaction rejections, you **MUST** record the warranty claim code provided on the Warranty Claim Code (WCC) screen shown above on the job card. Refer to callout 1 above for the location of the WCC on the screen.
