2020 Buick Truck Enclave AWD V6-3.6L

SPARK PLUG REPLACEMENT (BANK 1)

Document ID: 4757062

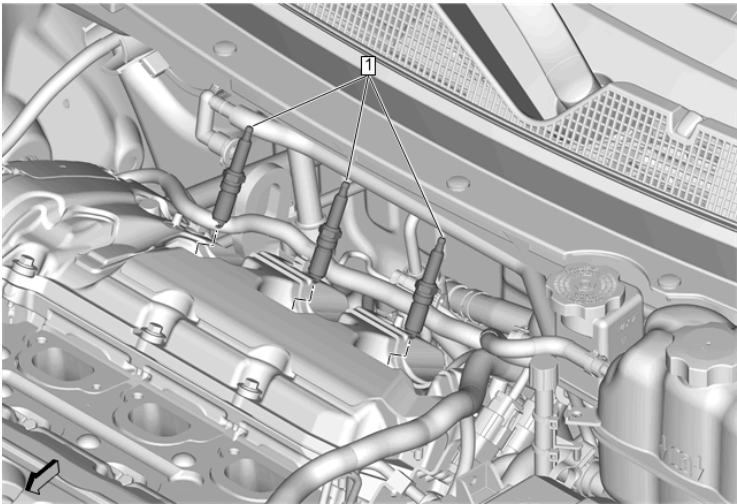
| Callout | Component Name |
|---|---|
| 1 | <div>Spark Plug [3x]</div> <div>Caution: Refer to Component Fastener Tightening Caution.</div> <div>Procedure</div> <div><div>1. If reusing the spark plugs, inspect for wear or damage. Spark Plug Inspection</div><div>2. If using NEW spark plugs, do NOT attempt to check the spark plug gap. The plugs come pre-gapped.</div></div> <div>Tighten</div> <div>18 Nm (13 lb ft)</div> |
